LIMITED FACILITY CONDITION ASSESSMENT REPORT

Kin Property #3397
416 Southbridge Street
Auburn, Massachusetts 01501

Blew Project # 24-6789.00
Report Date: September 25, 2024

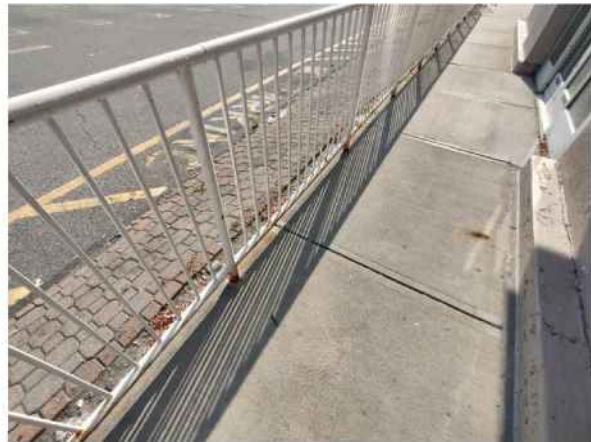
Site - flatwork and railings

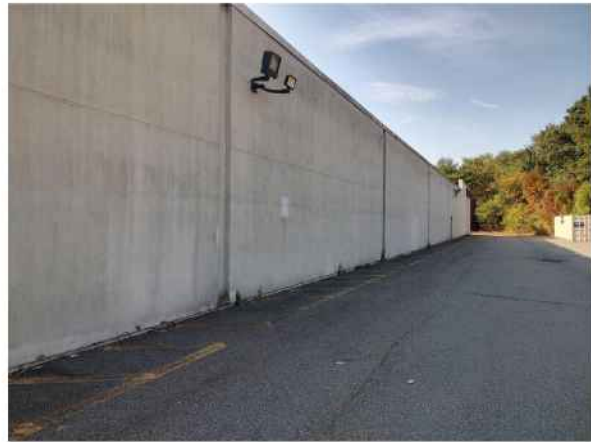
Site - lighting at facade

Installation of a new pole light in the parking lot is advised. Repair or replacement of a wall pack is advised. An opinion of cost is provided in the Capital Expenditures table.

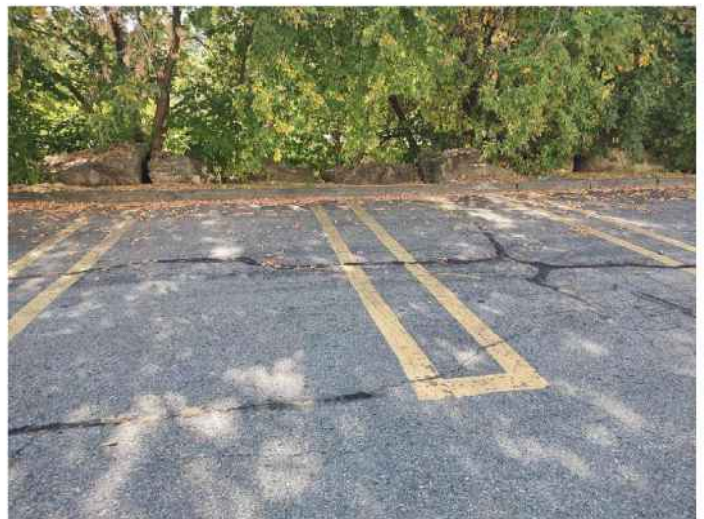
#4 Site - asphalt condition

The asphalt pavement exhibited some localized alligating, cracks, and deterioration in several locations throughout the site. To prevent further deterioration and mitigate tripping hazards, these should be repaired. Budgets for this work are included in the Cost Schedule.

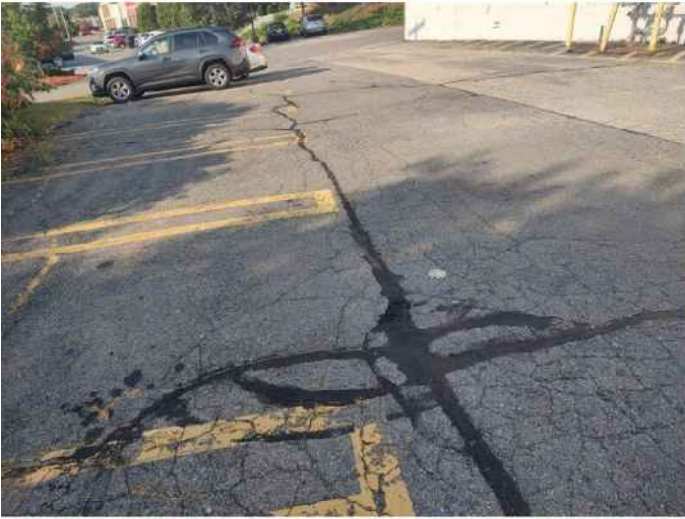
#9 Site - asphalt sealcoat condition

The parking area sealant and striping are in generally fair condition, with indications of wear. Based on the observed condition of the parking and drive areas, and the average effective useful life of pavement and pavement sealants, seal coating, and striping, periodic seal coating and striping is required.

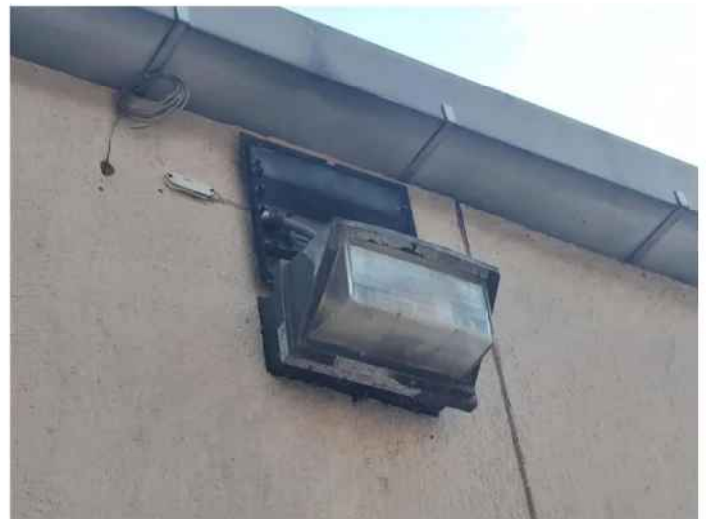
#16 Site - lighti

Item	Description	Action
Site Lighting	Site lighting consists of pole lights in the parking areas, and building-mounted lighting. One pole light is missing and replacement is advised. One wall pack on the west facade is dislocated from the mounting. Repair or replacement is advised.	IM

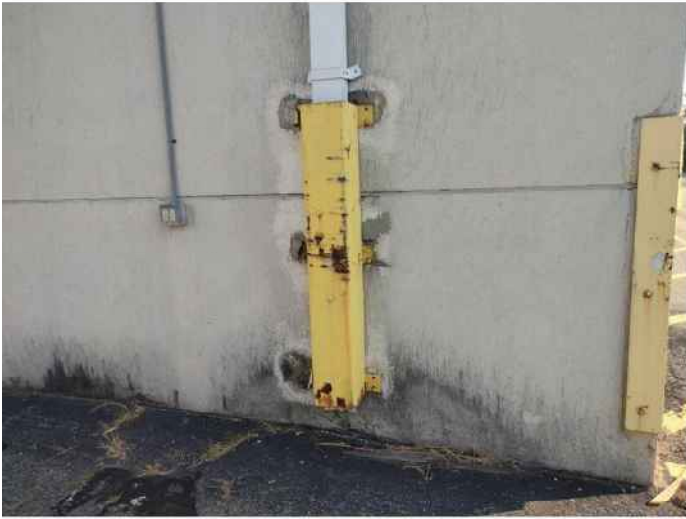
#37 Exterior - EIFS and metal condition

The EIFS facades are damaged at several locations adjacent to the loading docks and the approaching drive aisles. To prevent water infiltration, these areas should be repaired immediately. EIFS facades throughout are stained and dirty; painting the entire building after the repairs are completed is advised to present a uniform appearance of the exteriors.

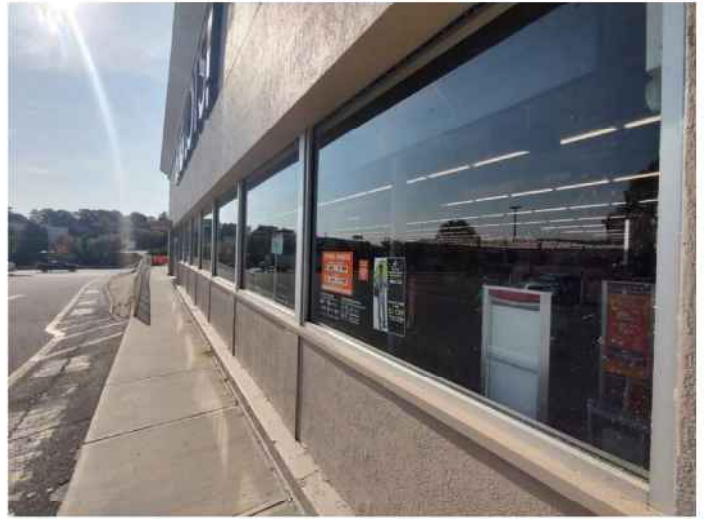
#45 Exterior - facade condition

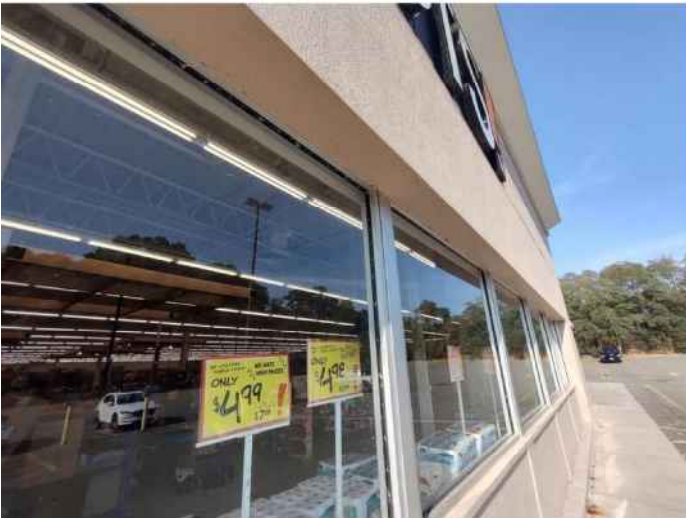
#46 Exterior - facade glazing and storefront

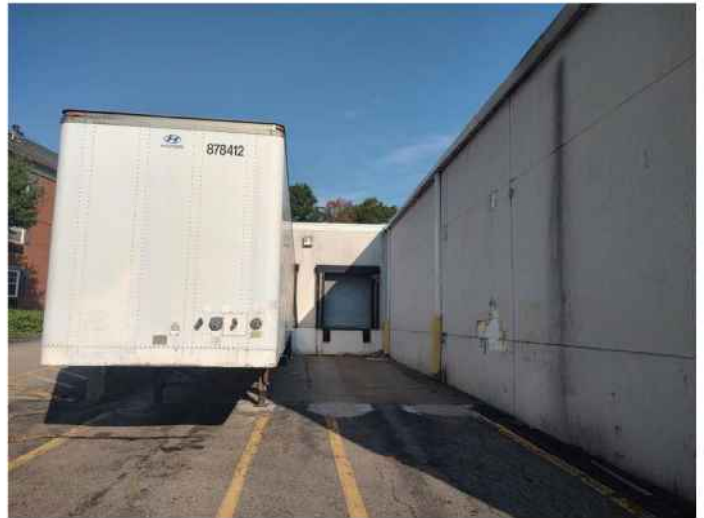
#47 Exterior - glazing and EIFS

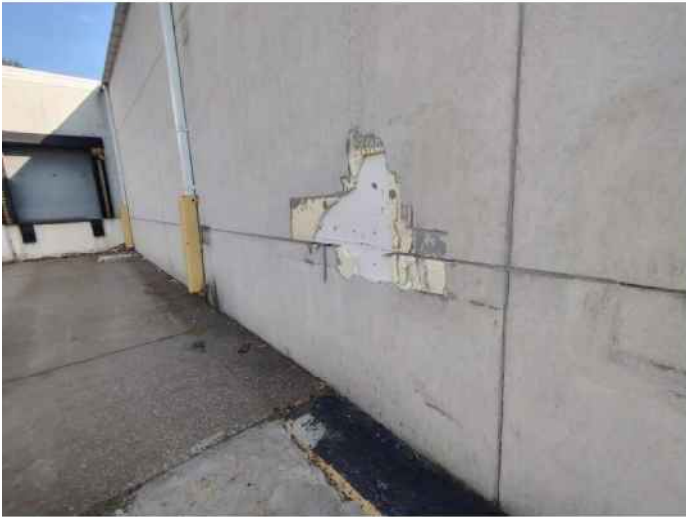
#48 Exterior - loading docks

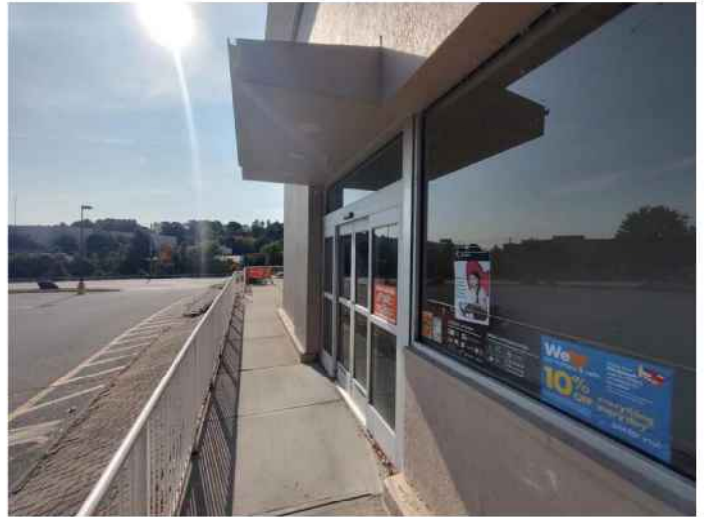
#49 Facade - EIFS condition

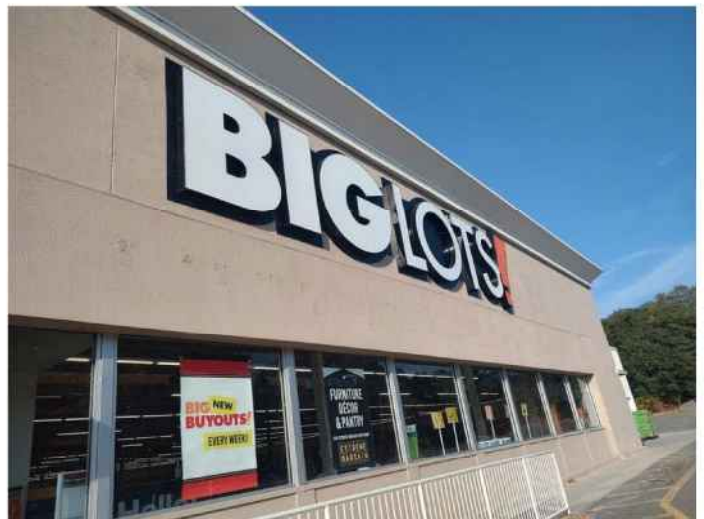
#51 Facade - secondary egress and EIFS

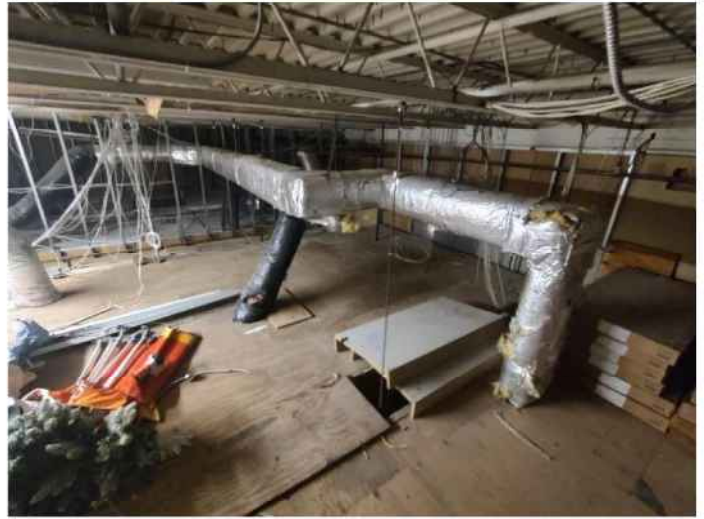
#53 HVAC

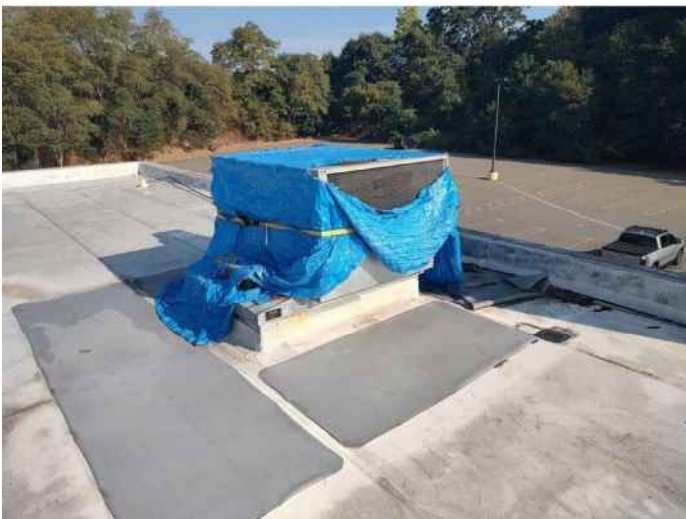
#54 HVAC - distribution ductwork

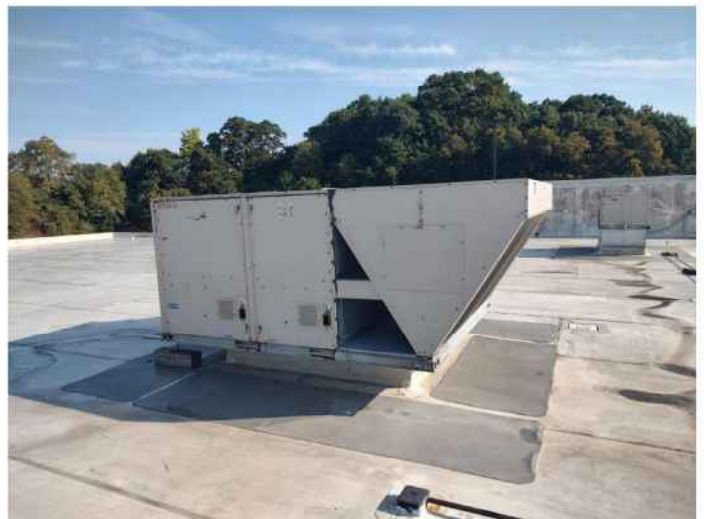
#55 HVAC - refrigeration unit (not in use)

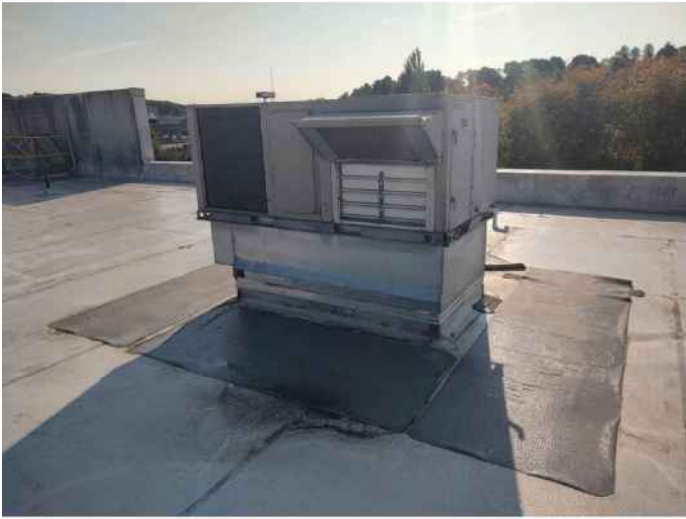
#56 HVAC - Rooftop unit

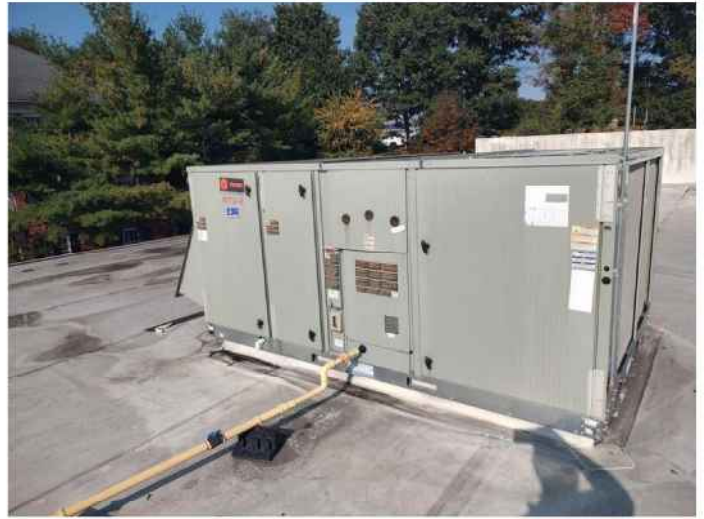
#57 HVAC - rooftop unit (RTU)

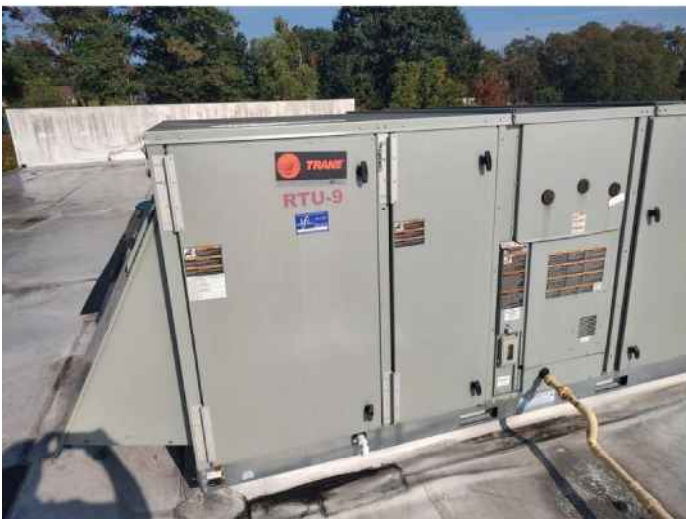
#58 HVAC - RTU

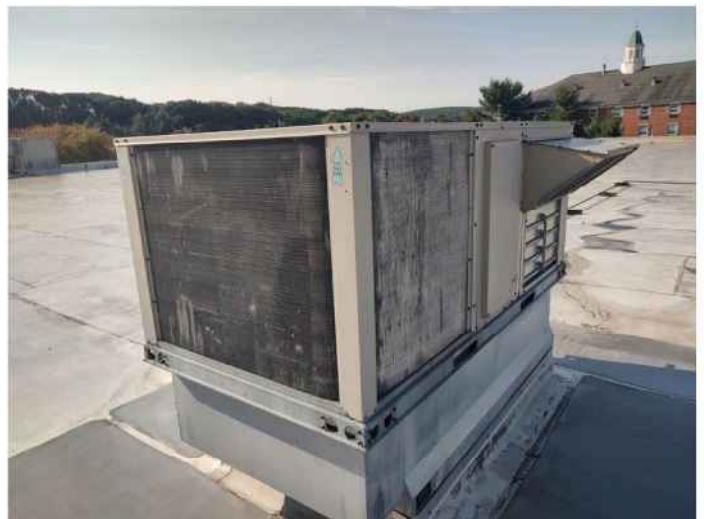
#59 HVAC - RTU

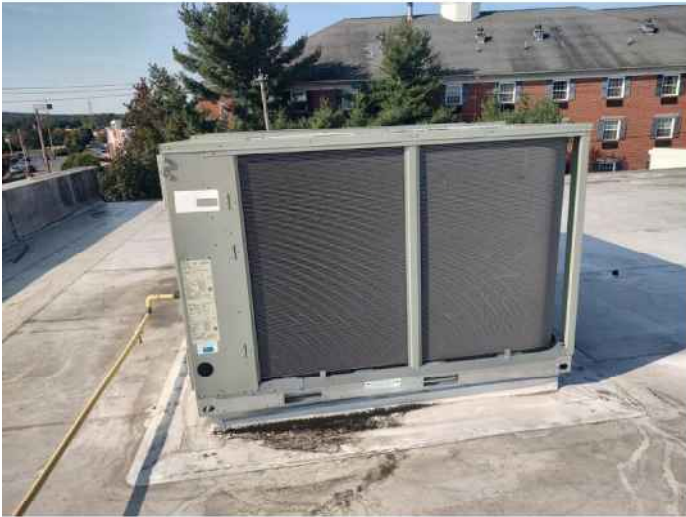
#60 HVAC - RTU

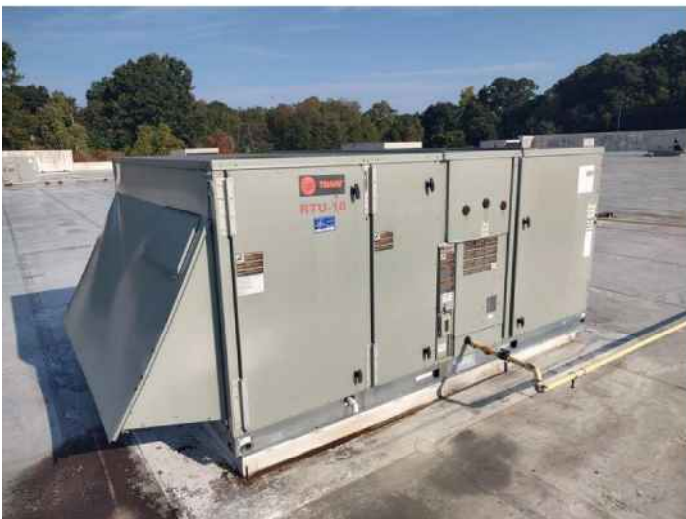
#62 HVAC - RTU Pad - #8

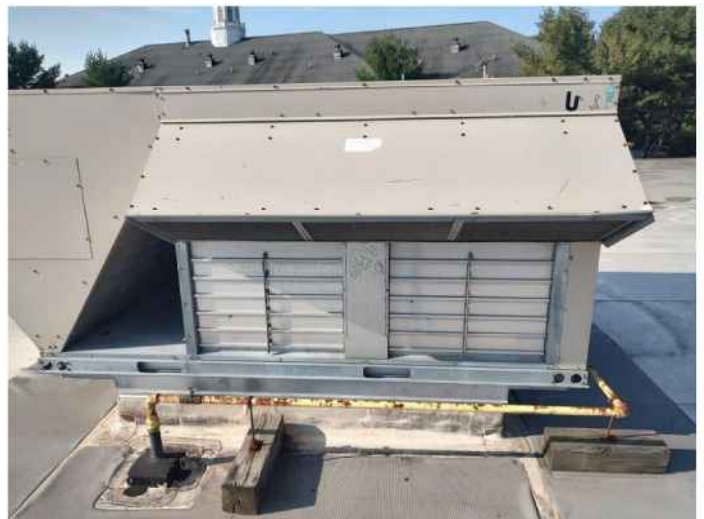
#63 HVAC - RTU

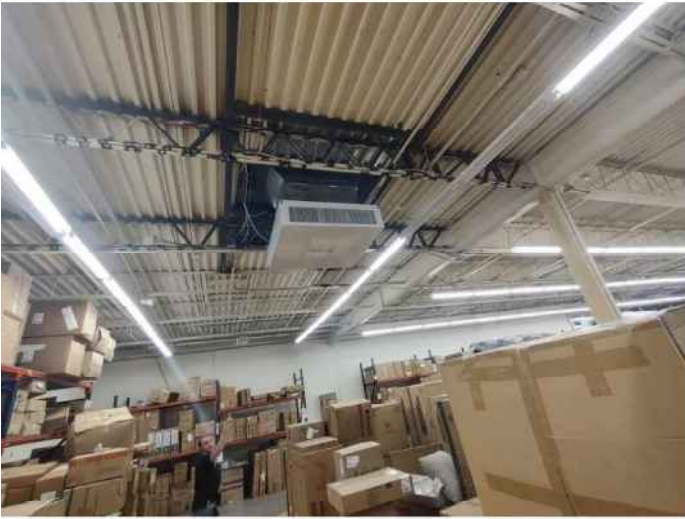
#64 HVAC - RTU and gas piping

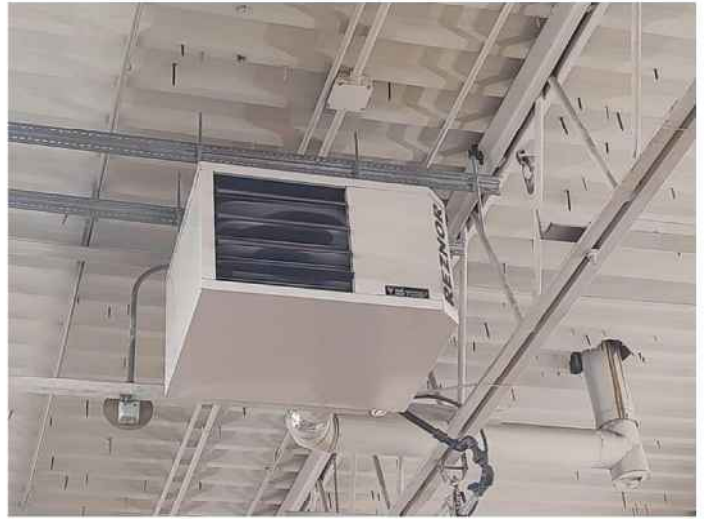
#65 HVAC - RTU at interior

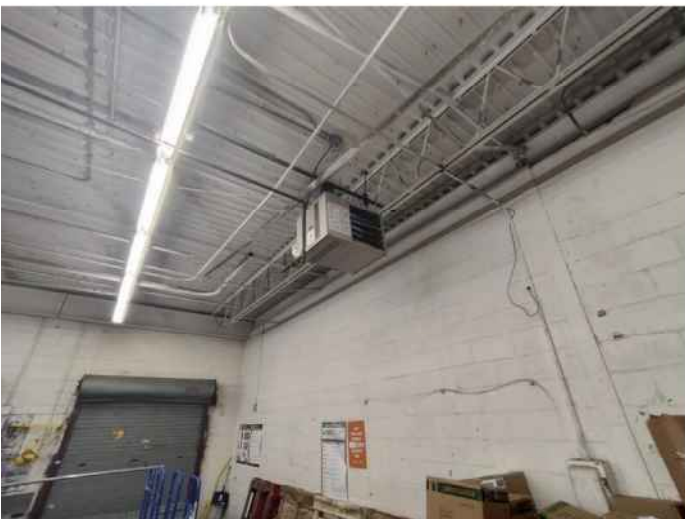
#66 HVAC - unit heater

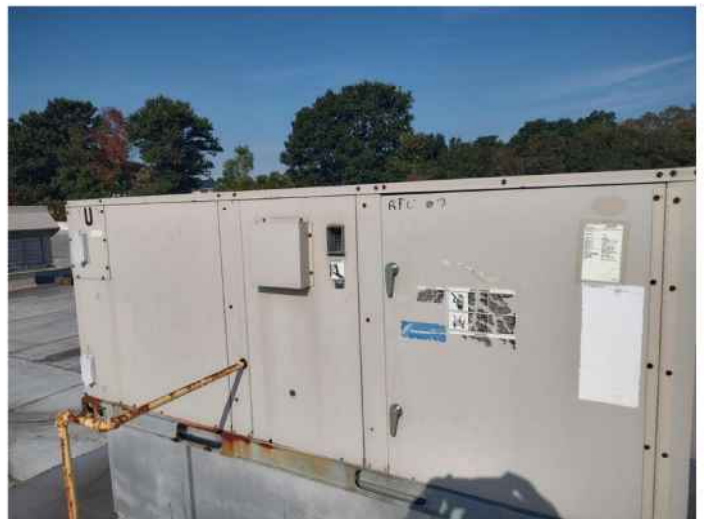
#67 HVAC - unit heater (

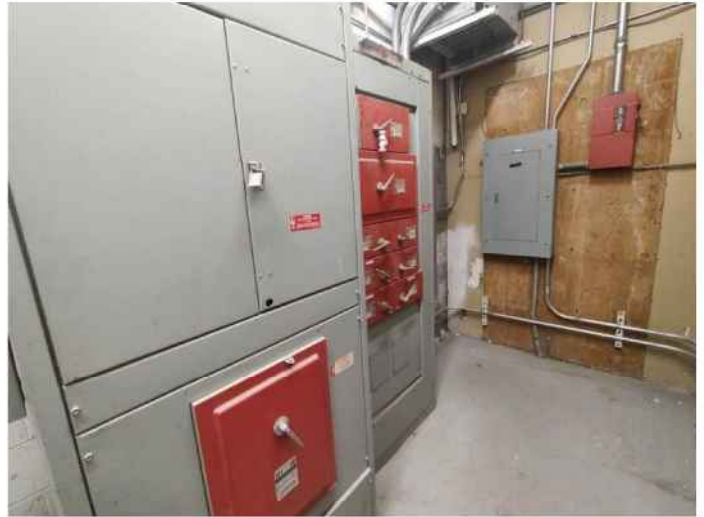
#69 Electrical - main disconnect

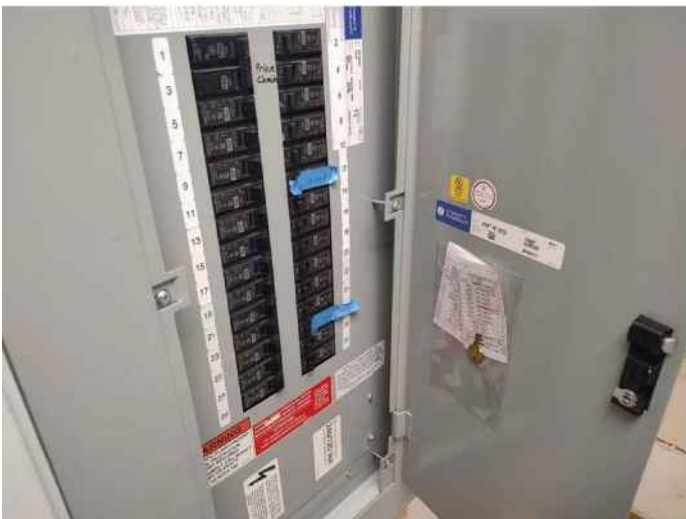
#70 Electrical - main switchgear

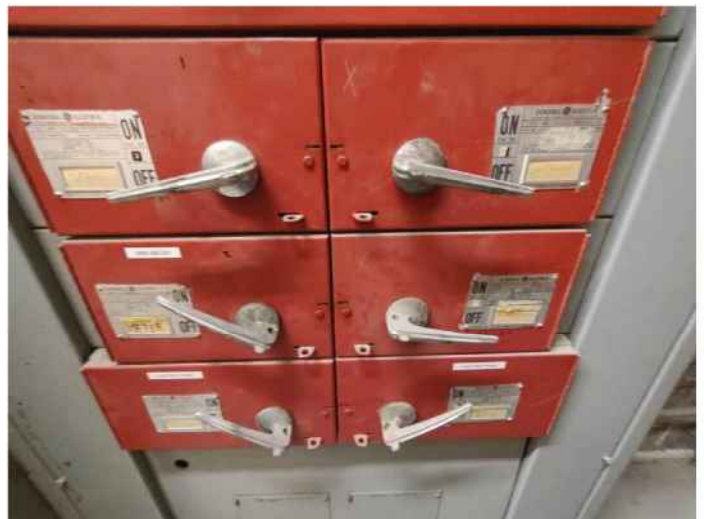
#71 Electrical - sub panel

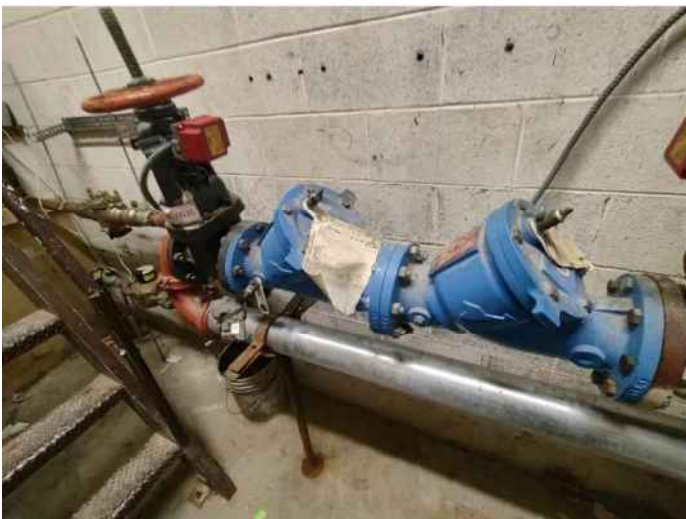
#78 FLS - sprinkler piping

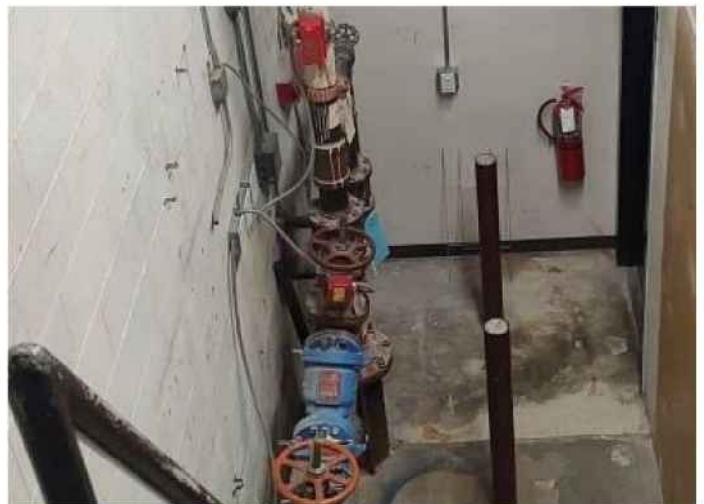
#79 FLS - sprinkler supply and backflow devices

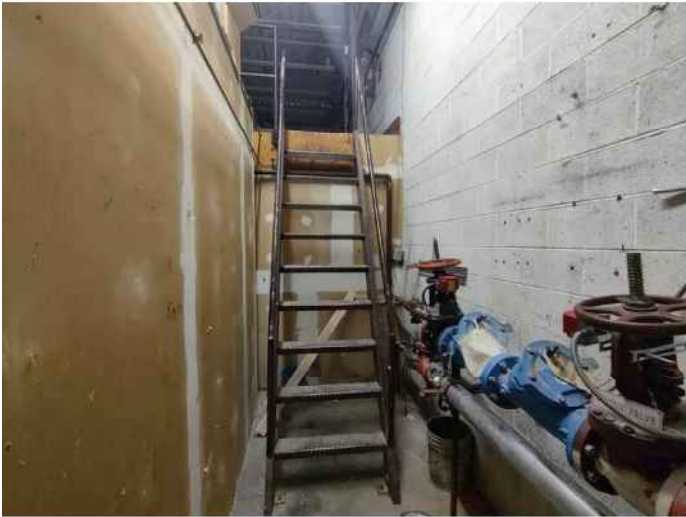
#80 FLS - Sprinkler system

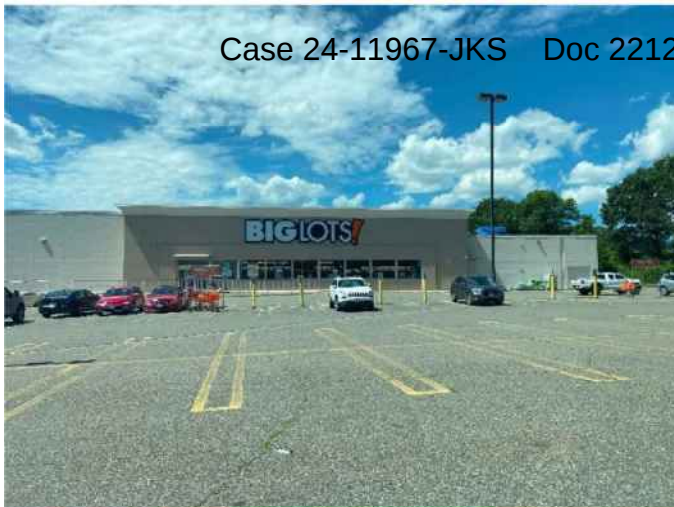
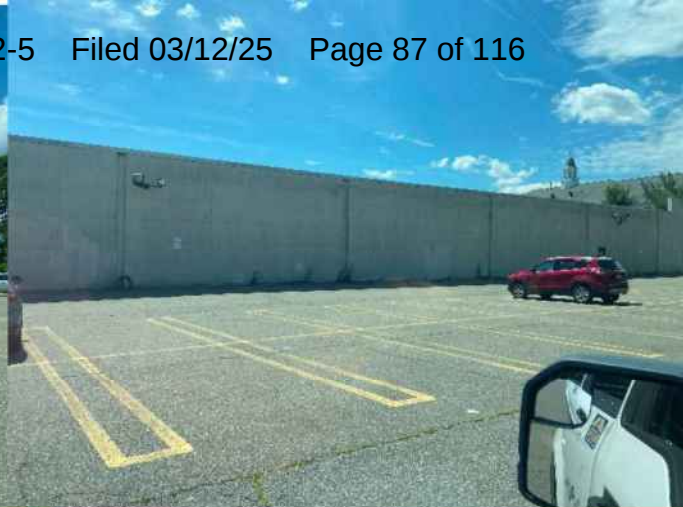
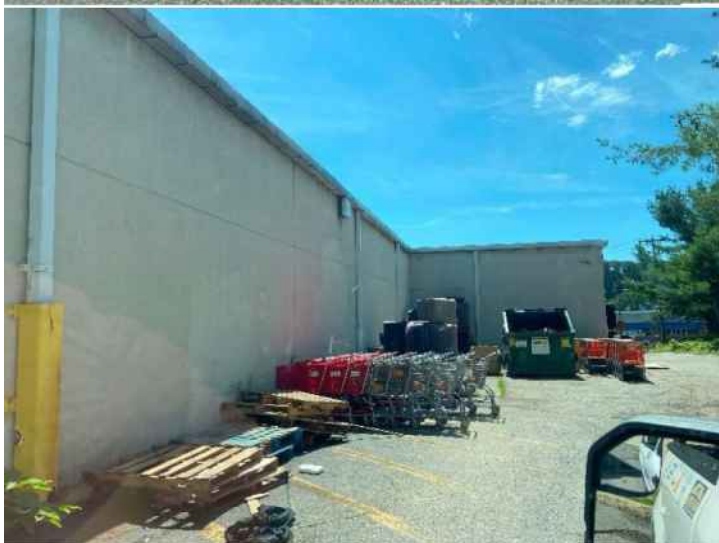
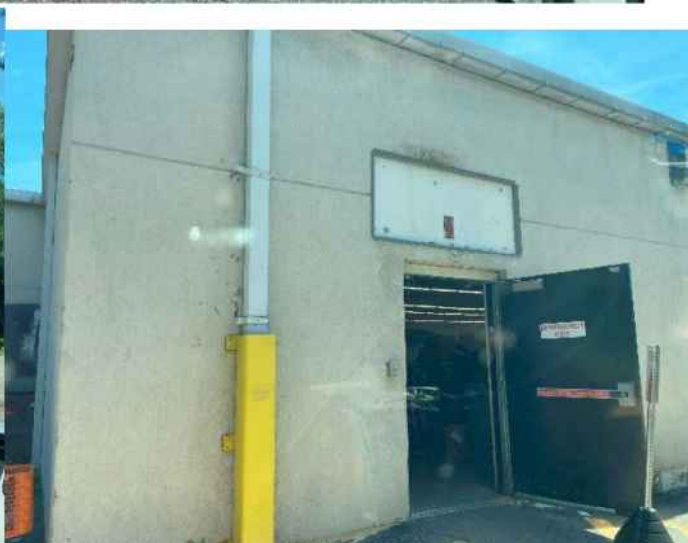
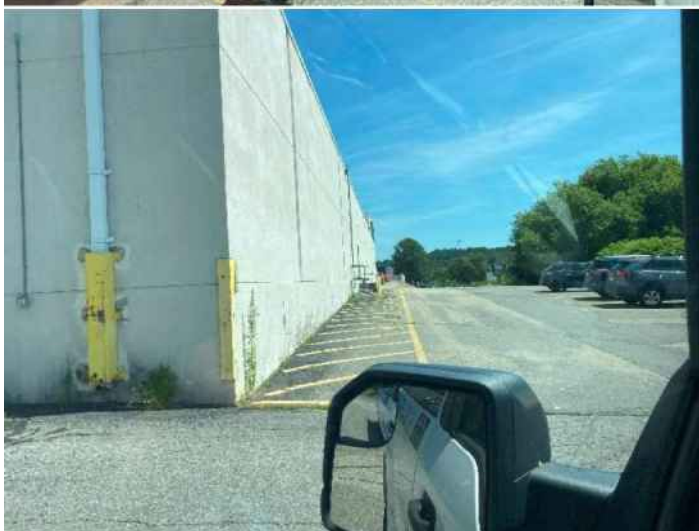
Type of roof: Modified ☐ BUR ☐ Single-ply ☒ Other:Type of deck: Tectum ☐ Metal ☒ Concrete ☐ Wood ☐ Gyp. ☐ Other:Condition of roof: Good ☐ Fair ☐ Poor ☒ Comments: Chalky, old, PVC membrane that has been patched in many places. Poor details at some areas. Areas of water damage of insulation near gutterCondition of parapets: Good ☐ Fair ☐ Poor ☒ Comments: Chalky, dirty, old PVC. Many patches. Poor details at many penetrations.Condition of flashings/edge details: Good ☐ Fair ☒ Poor ☐ Comments: Gutter is damaged across a long section. Other edge metal appeared to be in fair condition, color fading.Condition of rooftop units (HVAC units, fans, skylights, etc.): Good ☒ Fair ☐ Poor ☐ Comments: One exhaust fan was very low. One RTU was covered with a tarp.Can the existing roof be repaired economically? Yes ☐ No ☒ If yes, estimated repair cost: \$ and additional life of roof: years. Comments:If no, can the existing roof be overlayed? Yes ☒ No ☐ Comments: Building inspector must approve scope of work outlined in the proposal.

Comments and Recommendations: Roof appears to be at a stage where replacement is recommended.
